# Evaluation of GEVA-BOT cleaning device: Accelerated testing for Yingli modules installed in the Halutziot solar power plant

# PI-Report-Number: 201602410Ra\_V1\_Yingli\_GEVA-BOT

# 2017-01-27

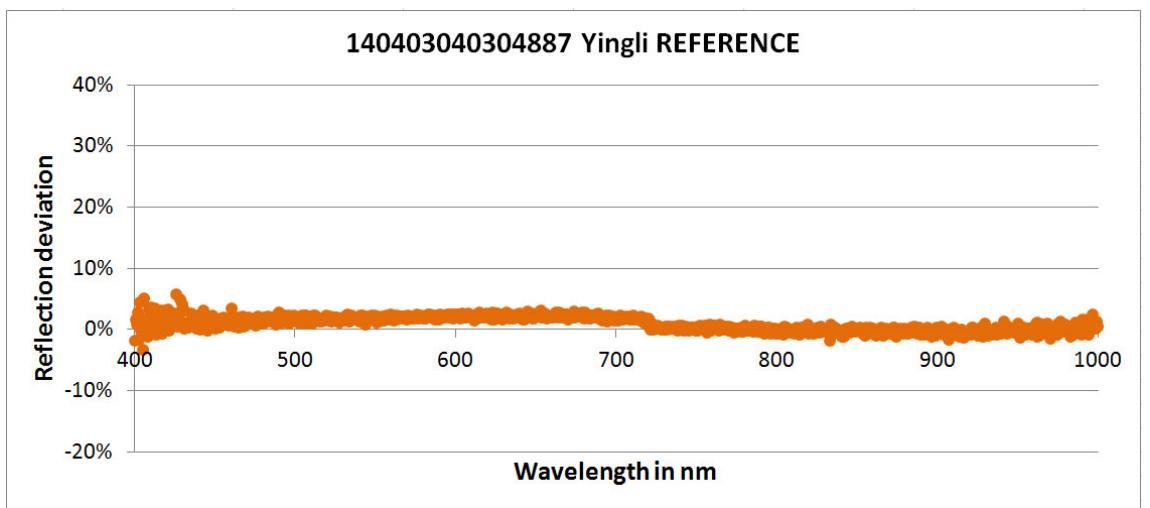
Figure 9: Results of the reflection measurement

All data points are located in the vicinity of the x-axis (the step at 720 nm is attributed to the use of two sensors and its imperfect merge). Furthermore, the average increase of reflection (over the whole range of wavelength and measured positions) is about 1% which is smaller than the measurement uncertainty of 3%. Therefore no change in reflection could be measured.

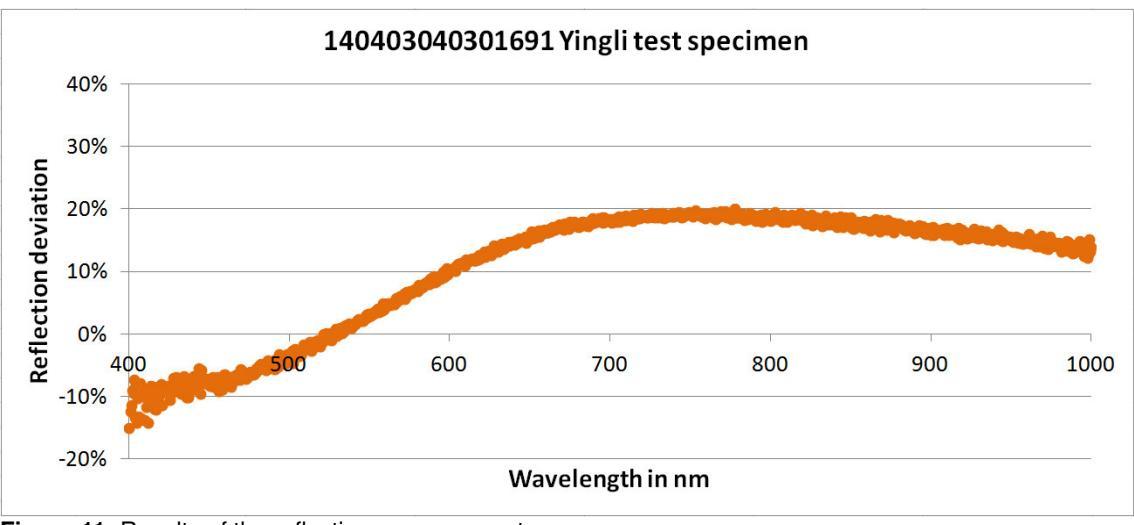
Figure 11: Results of the reflection measurement

The data points within the wavelengths < 550 nm reveal a slight decrease of reflection whereas for measurements > 550 nm clearly an increase of reflection is recognizable. The average increase of reflection (over the whole range of wavelength and measured positions) is about 11%.

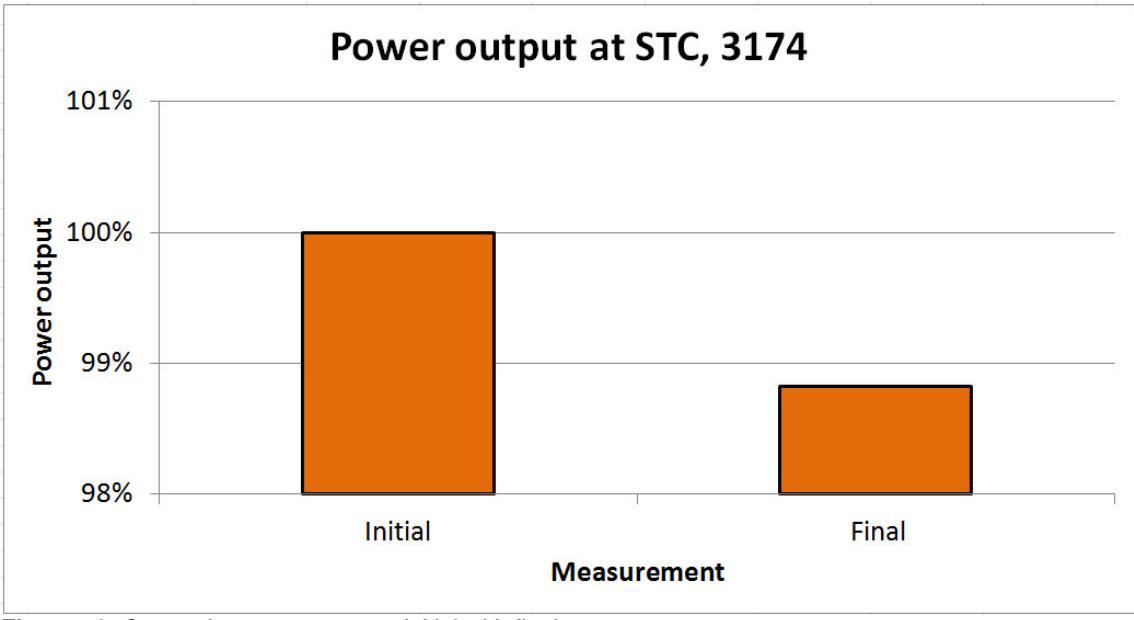
Figure 12: Comparison power output initial with final measurement

The comparison shows that the power output deviation is -1.18% to the initial measurement. A slight recognizable decrease of power output could be measured.

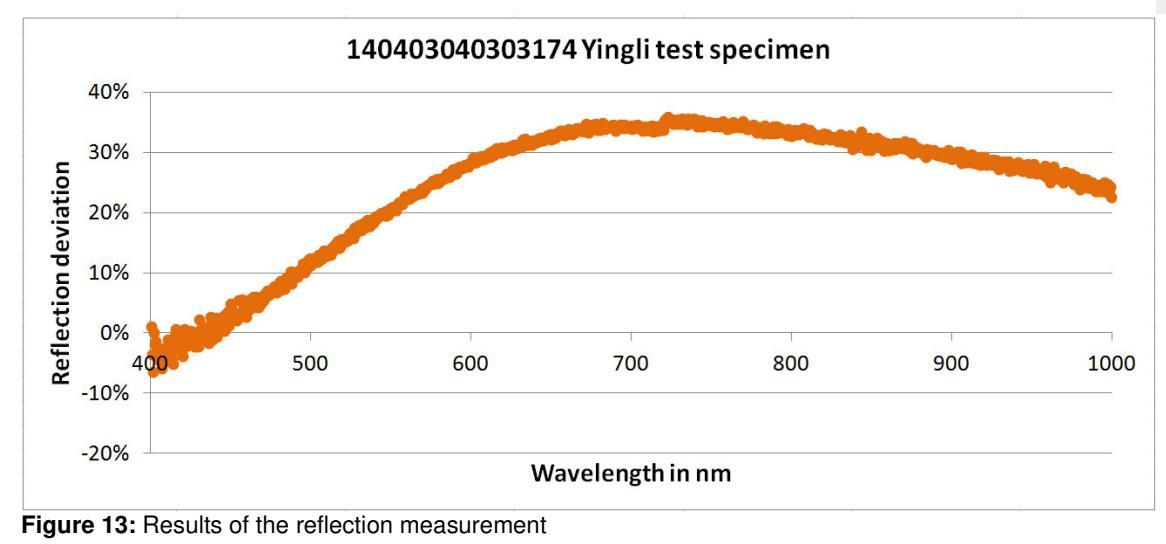
The data points within the wavelengths < 450 nm reveal a very slight decrease of reflection whereas for

measurements > 450 nm clearly an increase of reflection is recognizable. The average increase of reflection (over the whole range of wavelength and measured positions) is about 25%.

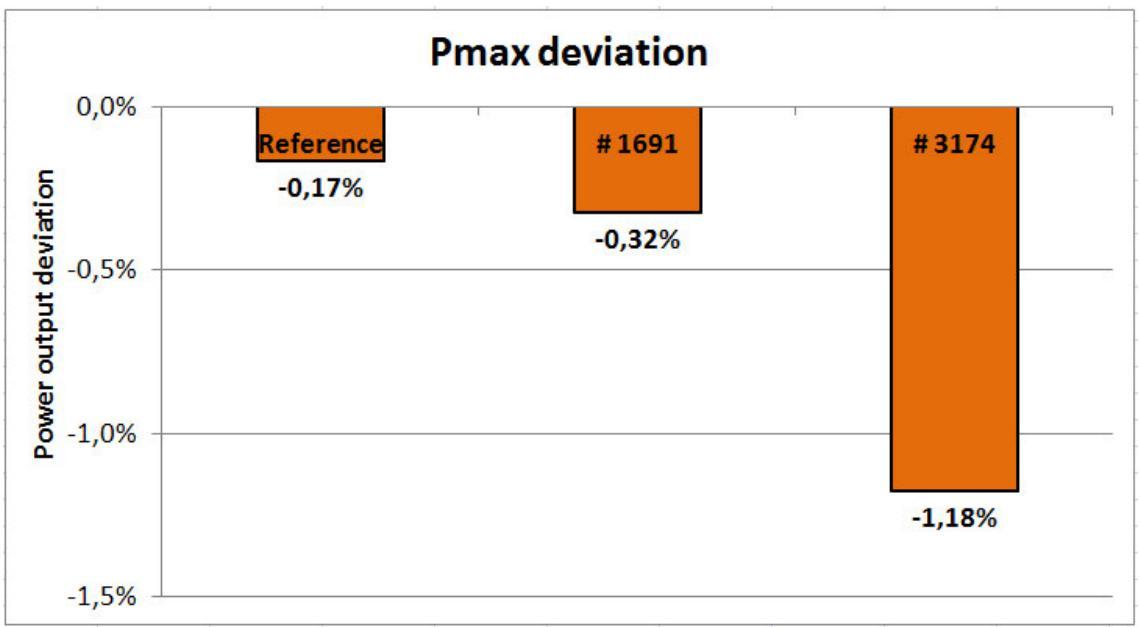
Figure 14: Comparison of maximum power output deviation after cleaning

The reference and the module with the serial number ending #1691 have shown no recognizable power output deviations compared to the initial measurement. The module with the number #3174 reveals a slight decrease of -1.18% compared to the initial characterization by exceeding the repeatability error of the flashlight sun simulator (Figure 14).

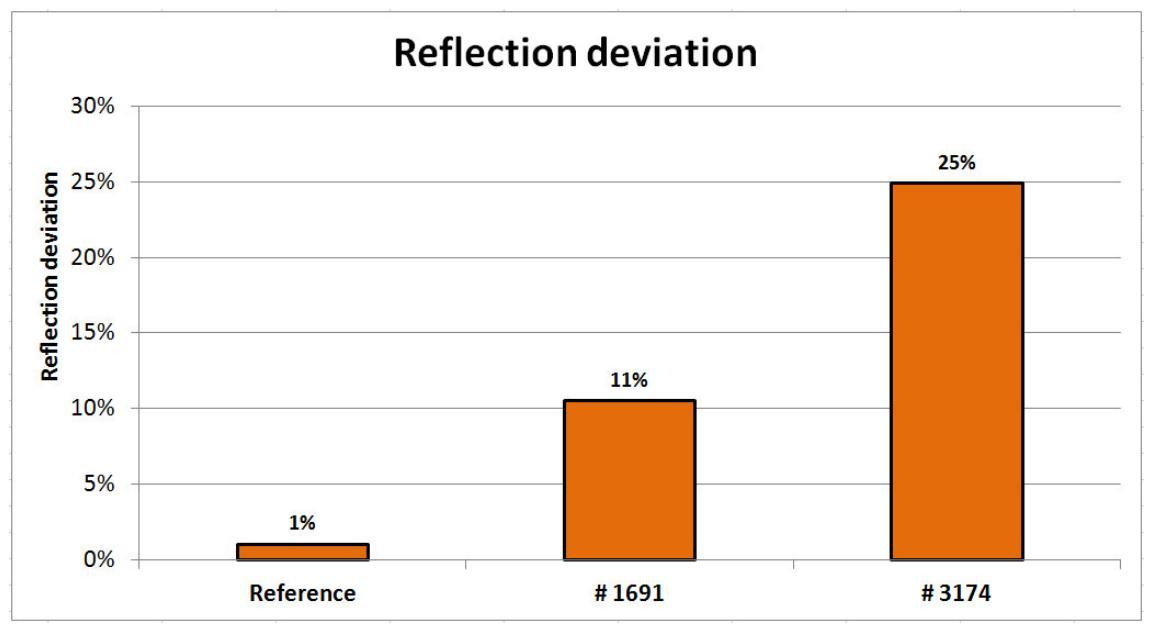
Figure 15: Comparison of reflection deviation after cleaning

This comparison shows that the increase of reflection is quite different of the both test specimen despite the equal mounting positions on the rack and next to each other. However, the results show that there is a measurable influence from the cleaning process on the modules antireflective coating, especially on the module with the serial number ending #3174. Taking into consideration the internal pass/fail criteria of 10% deviation and the measurement uncertainty of  $\pm 3\%$ , only this one module fails.

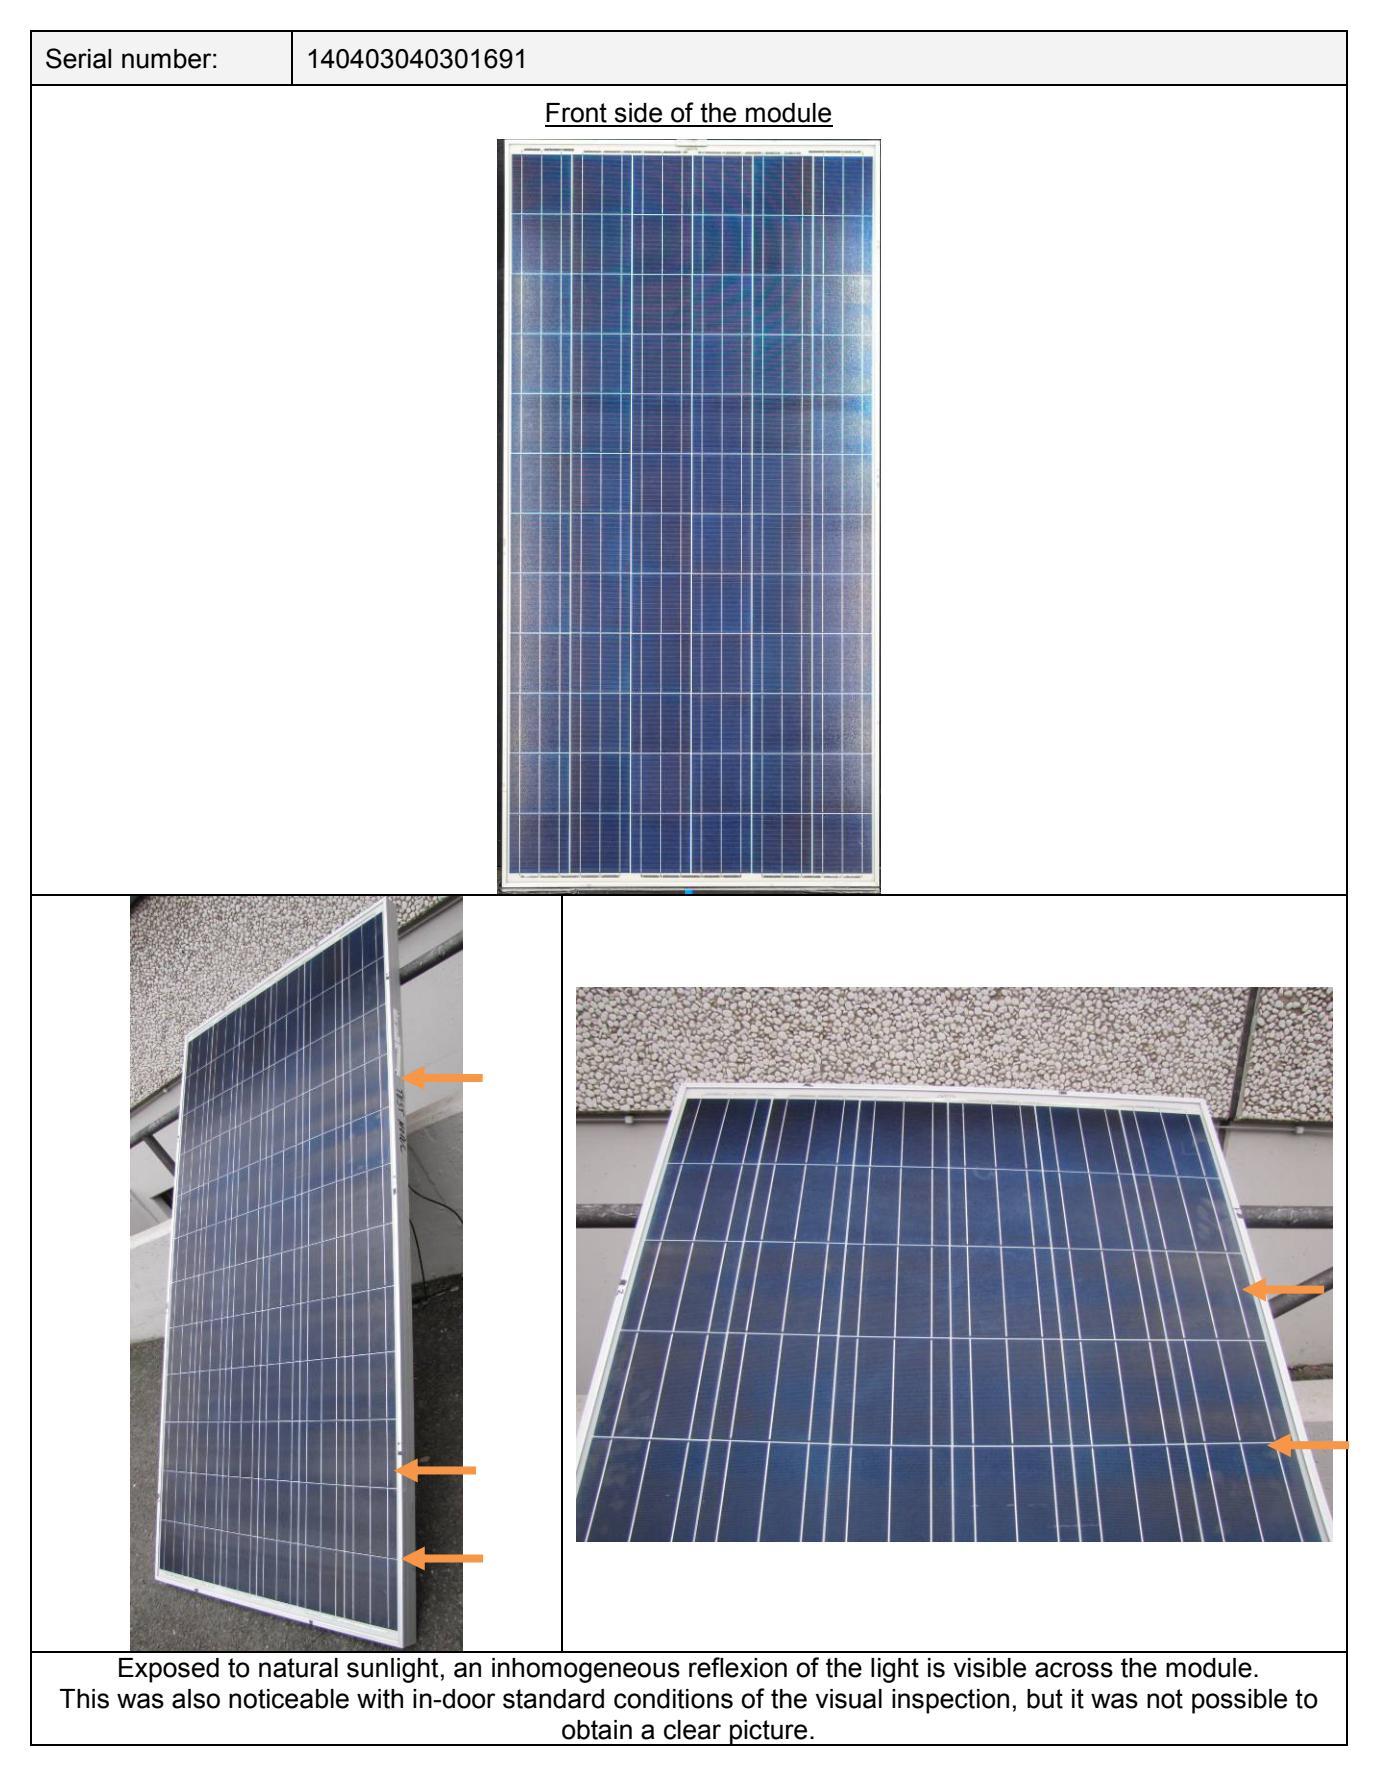
### Visual Inspection after accelerated test::

Serial number	Level	Condition
140403040301691	Initial	Apart from scratches here and there on the front side, there is no major defect to report (refer to following pages for details).
	Final	Change in the anti-reflexion coating (refer to the following pictures for details). It is also visible only when these areas are exposed to direct light, at these particular areas the light reflexion is changed.
140403040303174	Initial	Apart from scratches here and there on the front side, there is no major defect to report (refer to following pages for details).
	Final	Change in the anti-reflexion coating (refer to the following pictures for details). It is also visible only when these areas are exposed to direct light, at these particular areas the light reflexion is changed.
140403040304887	Initial	Apart from scratches here and there on the front side, there is no major defect to report (refer to following pages for details).

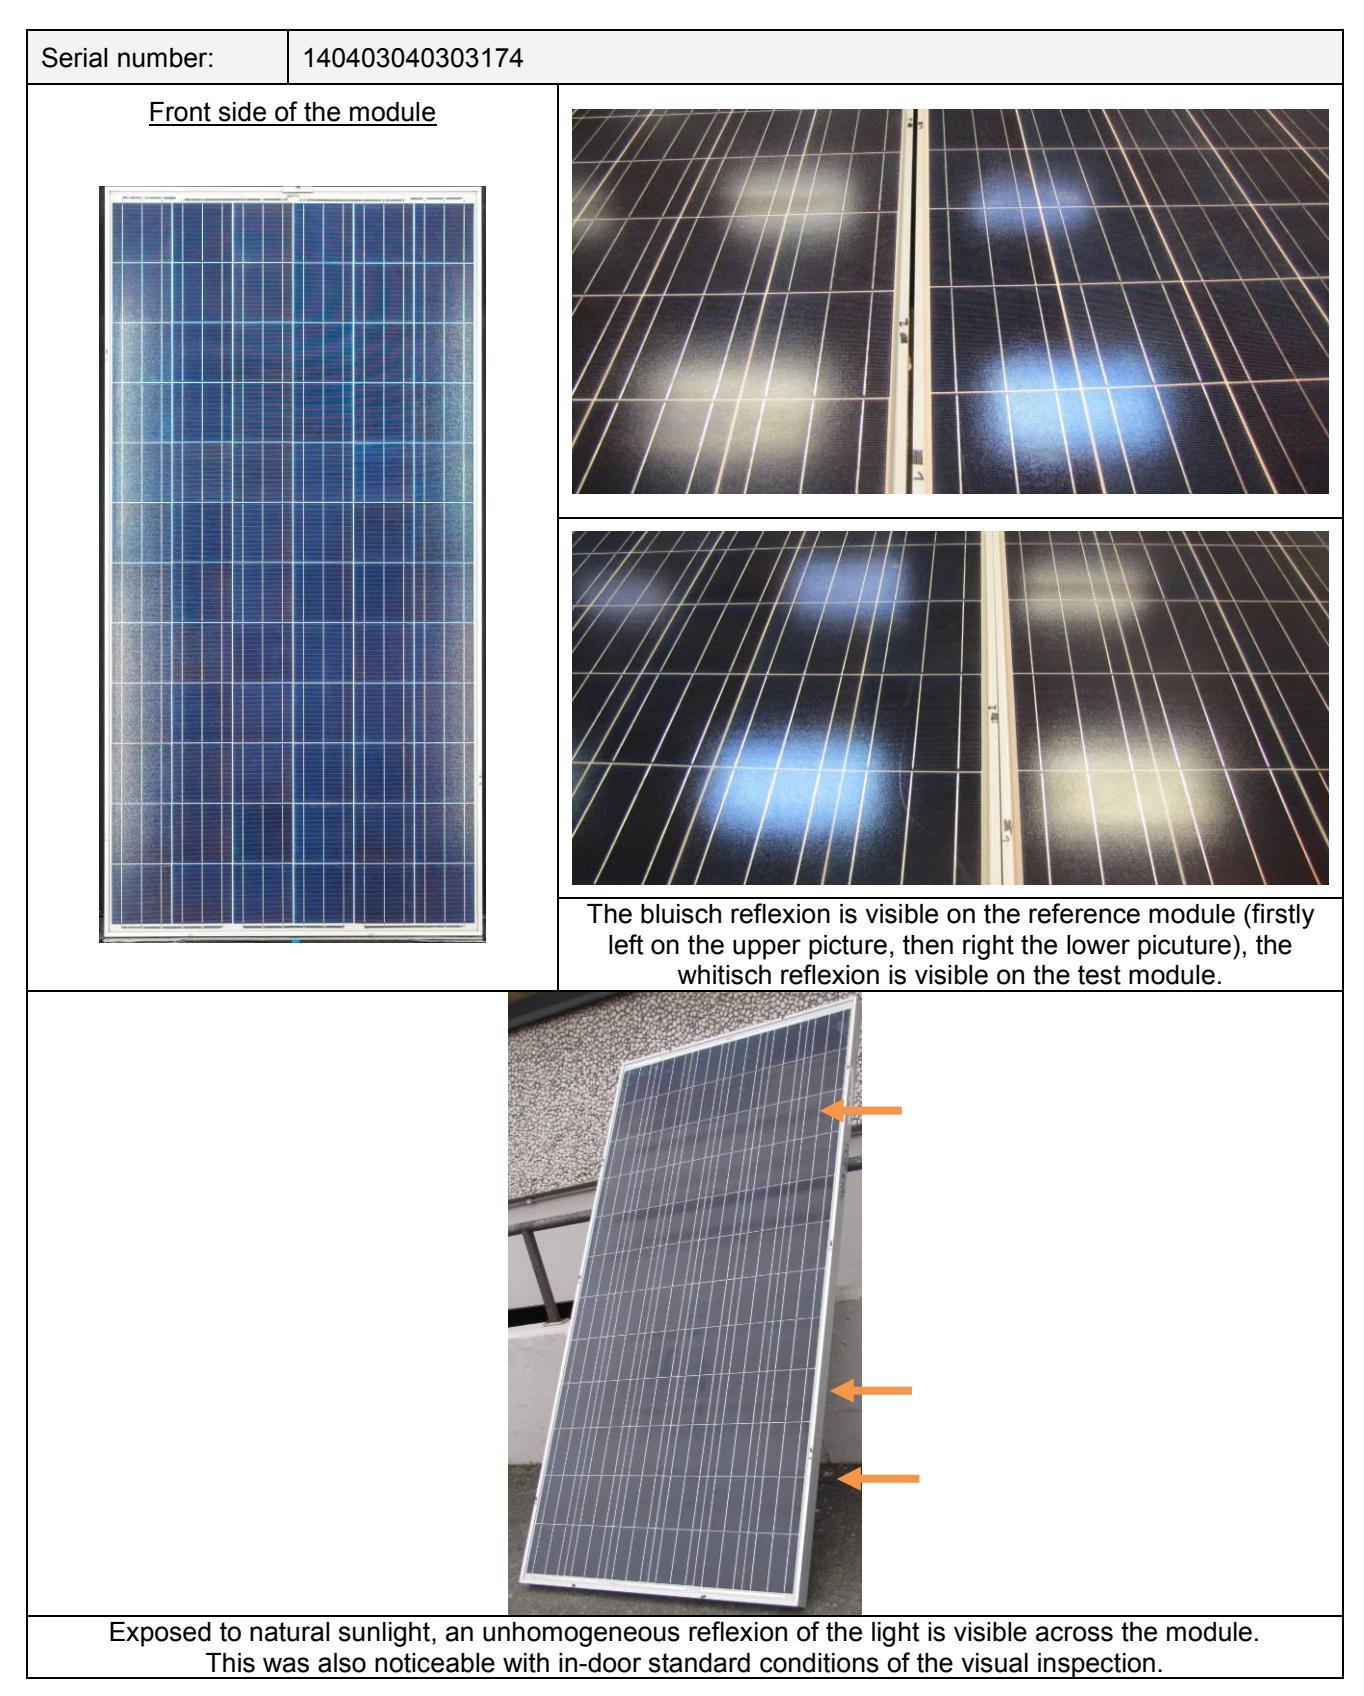
### Visual Inspection after accelerated test:

From visual inspection it could be observed that the accelerated cleaning did not cause any scratches on the glass surface but a visible change of the module glare as well as darker stripes within the cleaning direction of the robot which indicates an influence of the robot on the antireflective glass coating.
