# Evaluation of GEVA-BOT cleaning device: Accelerated testing for Yingli modules installed in the Halutziot solar power plant

# PI-Report-Number: 201602410Ra\_V1\_Yingli\_GEVA-BOT

# 2017-01-27

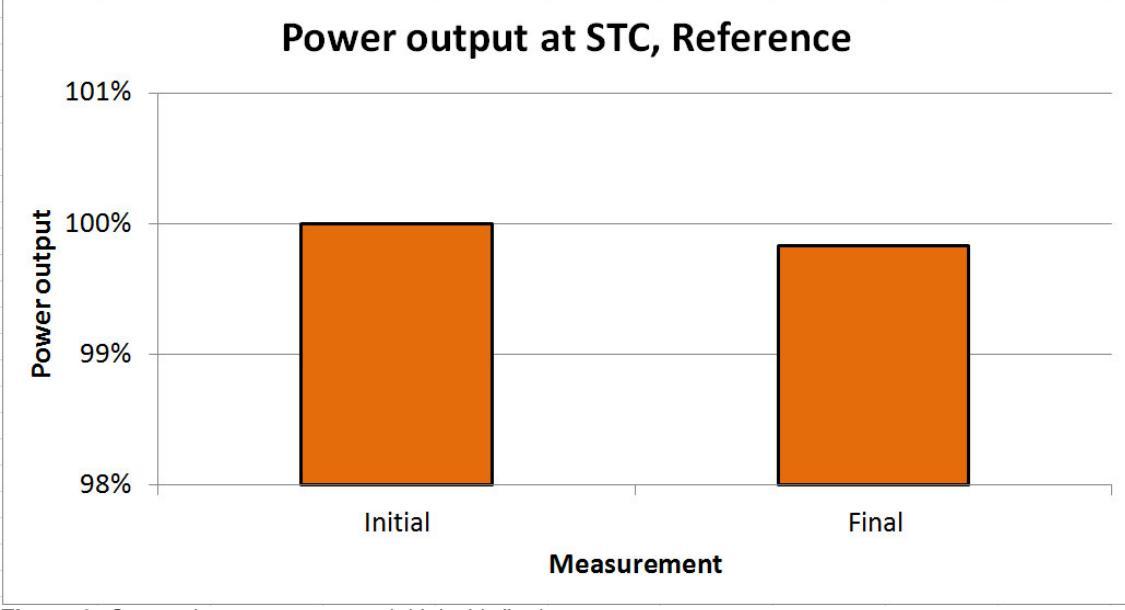
Figure 8: Comparison power output initial with final measurement

The comparison shows that the power output deviation is -0.17% to the initial measurement which is within the repeatability error of the flasher (0.33%). Therefore, no measurable change in power output could be proven.

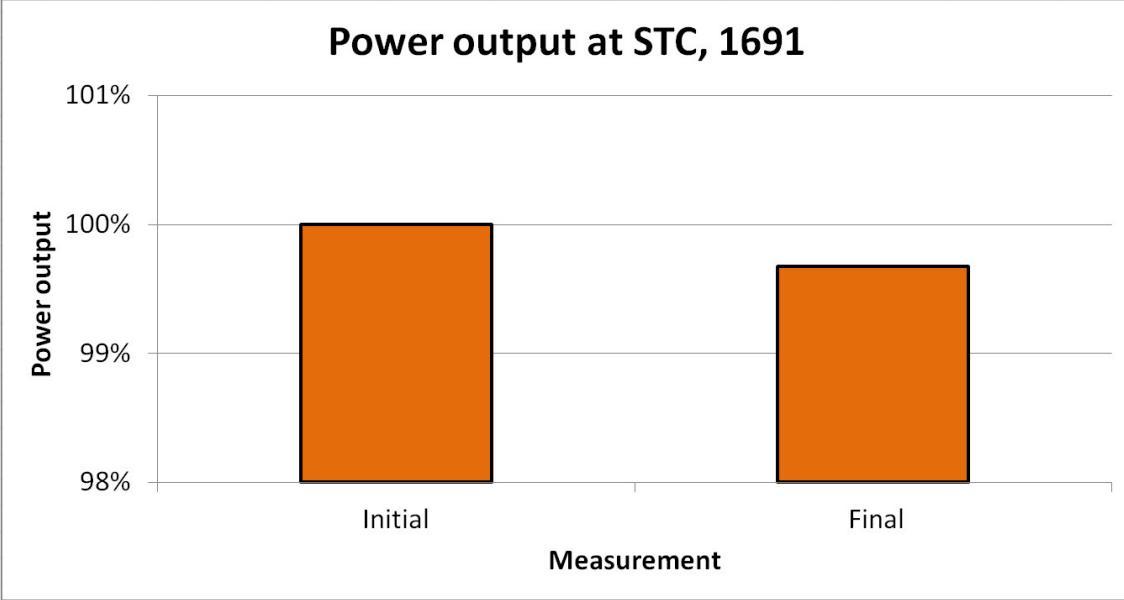
Figure 10: Comparison power output initial with final measurement

The comparison shows that the power output deviation is -0.32% to the initial measurement which is within the repeatability error of the flasher (0.33%). Therefore, no measurable change in power output could be recognized.

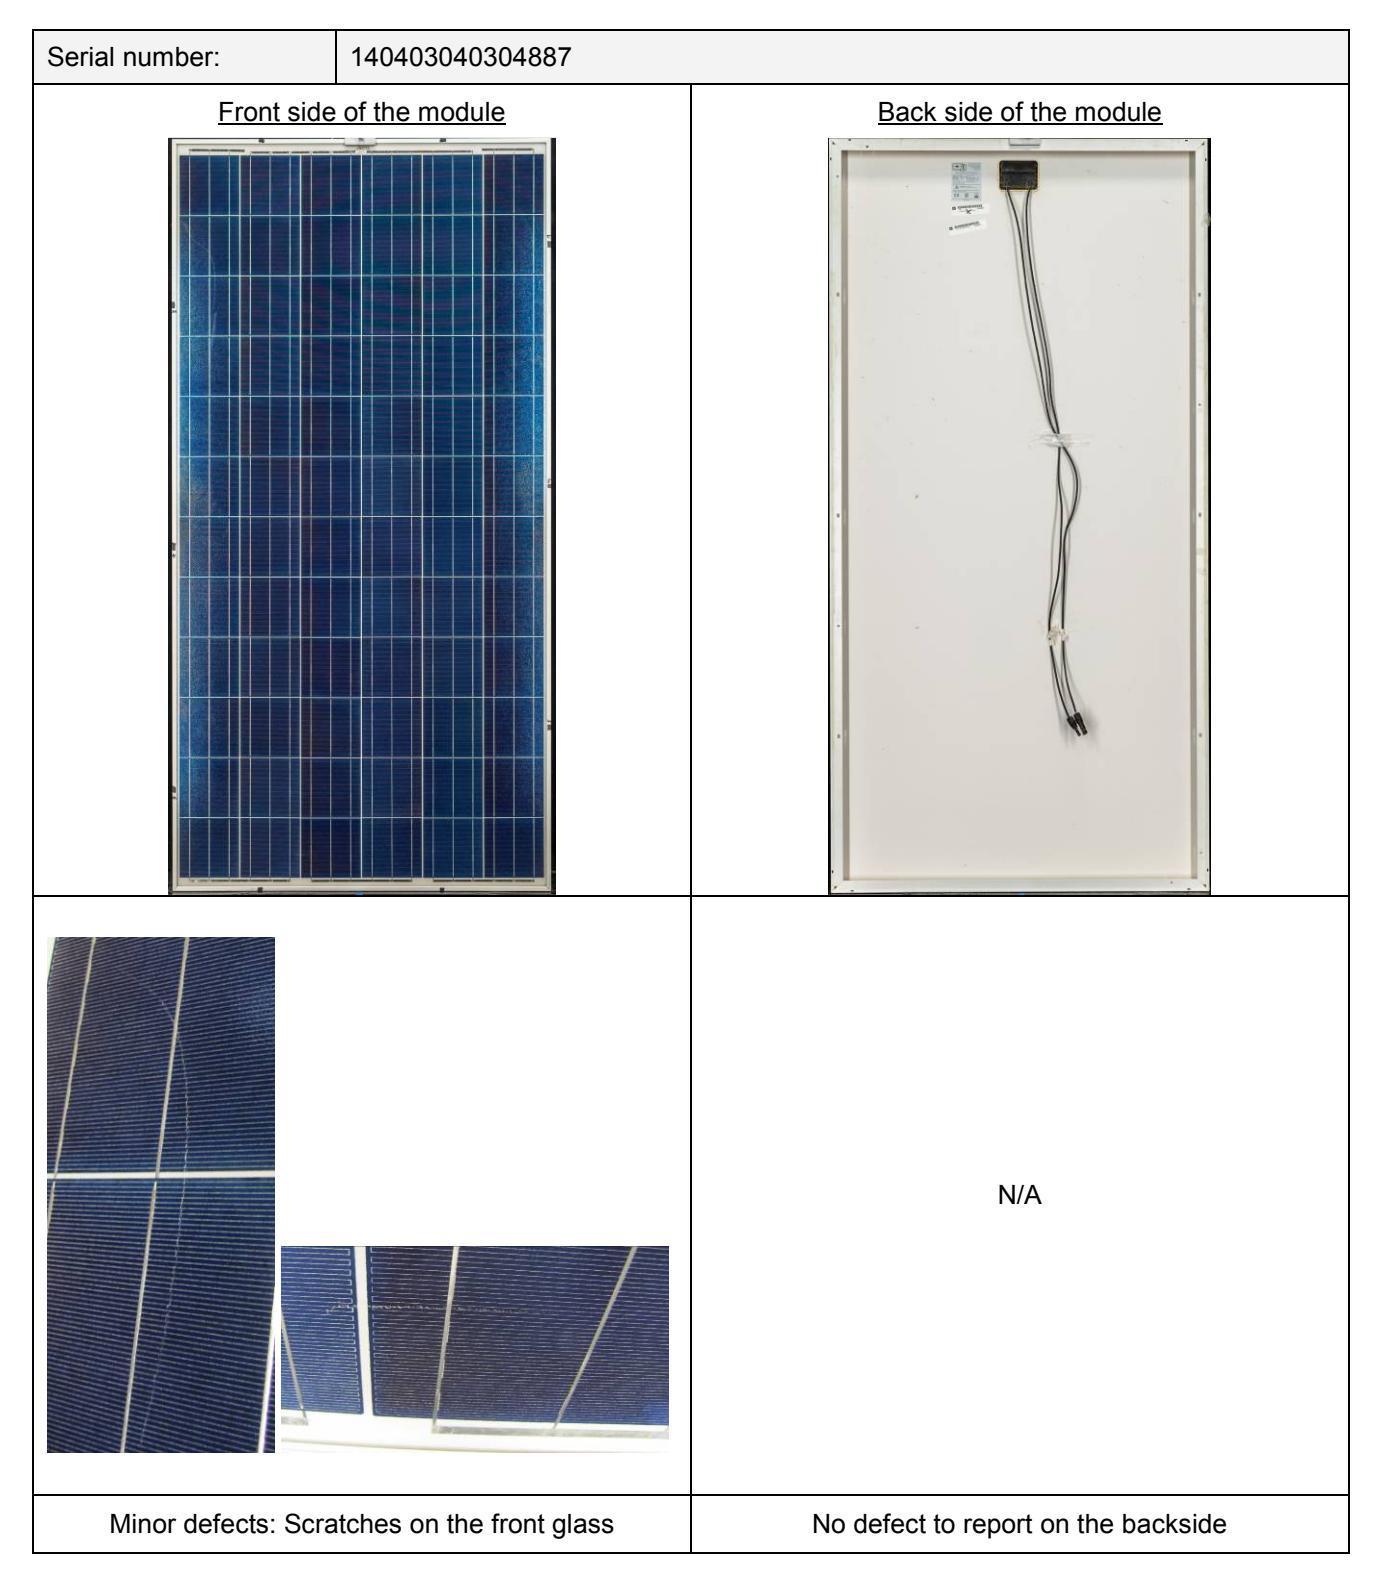
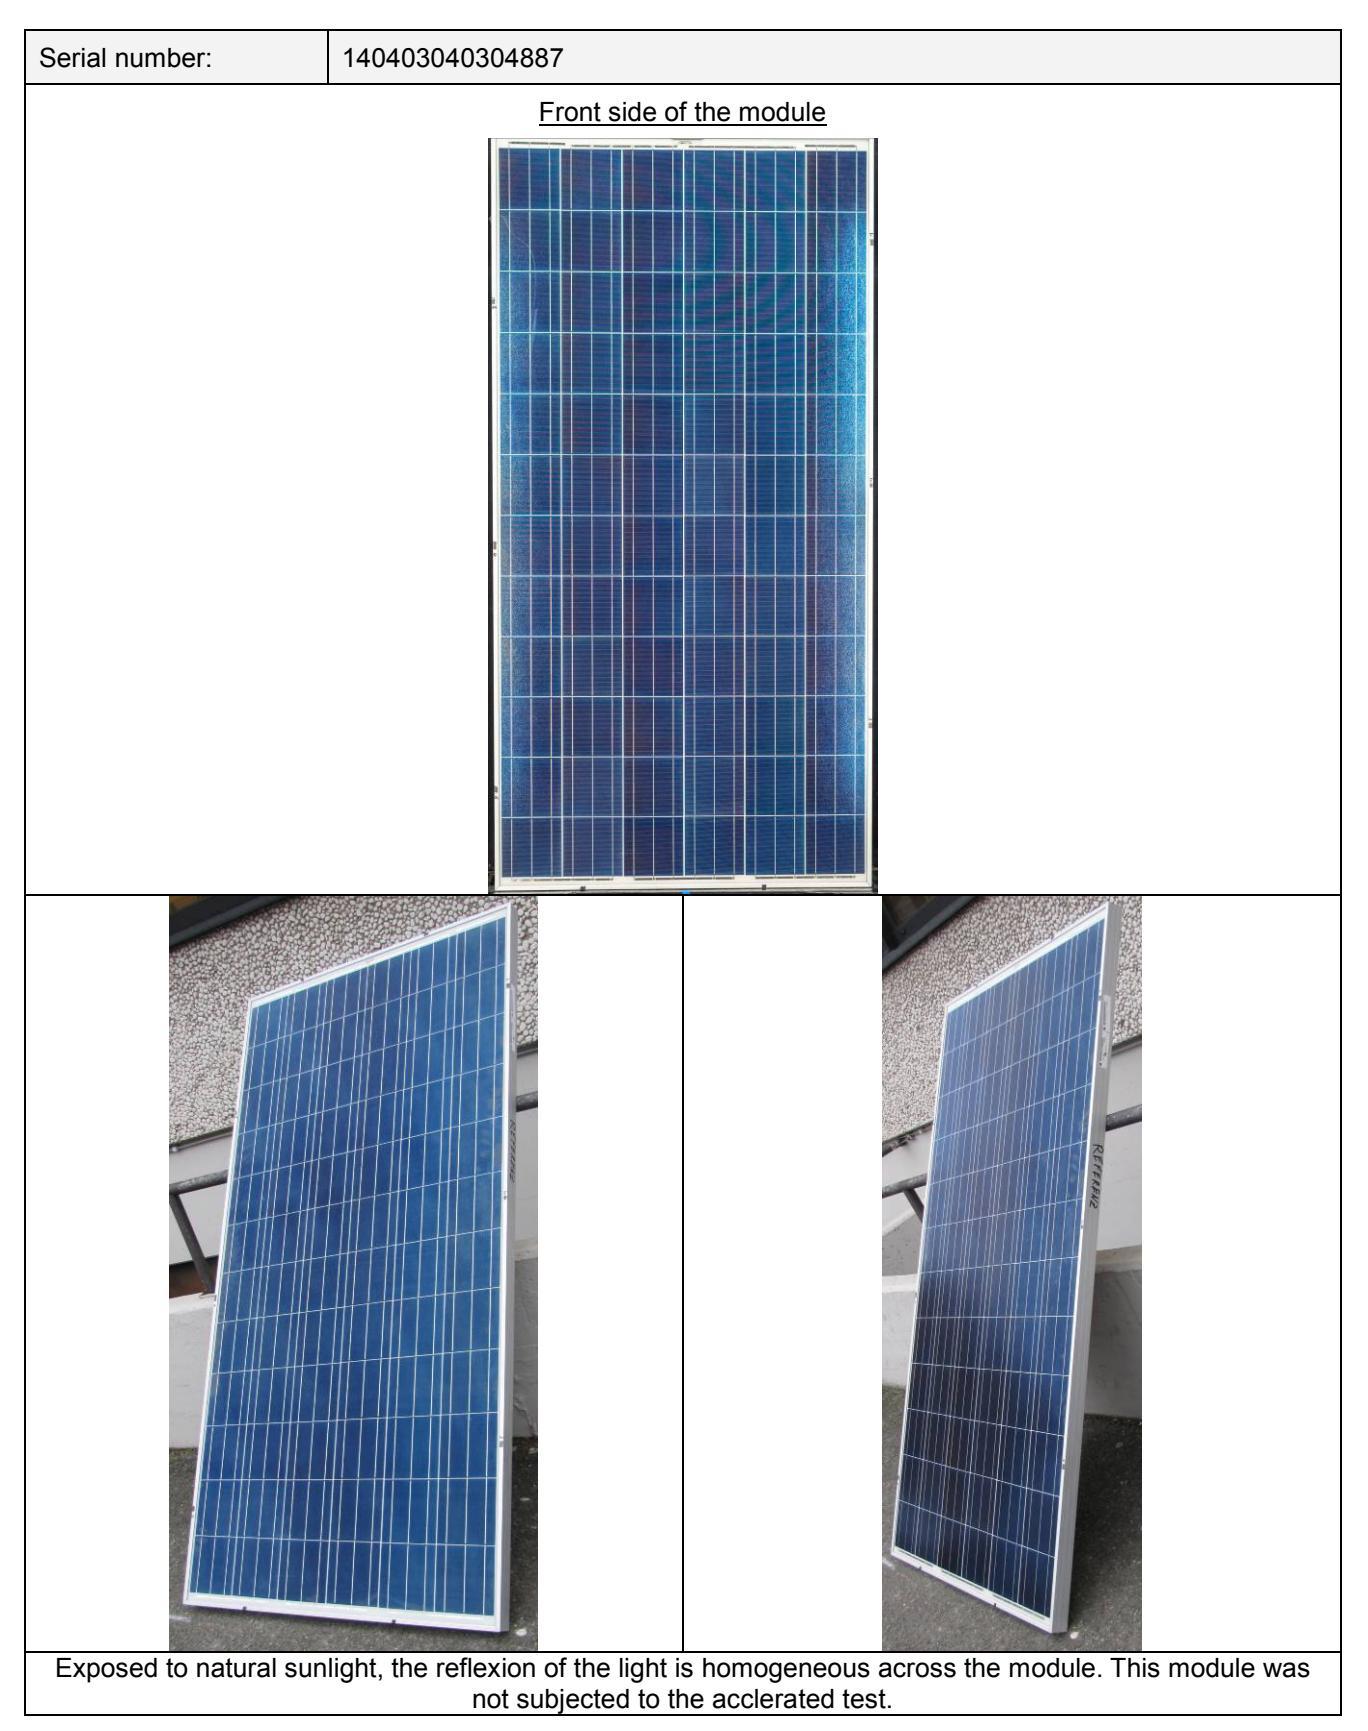
No visual changes could be observed on the reference module at the measurements before and after the accelerated cleaning test (201602410La\_V1\_Yingli\_Solar section 3.3.3).

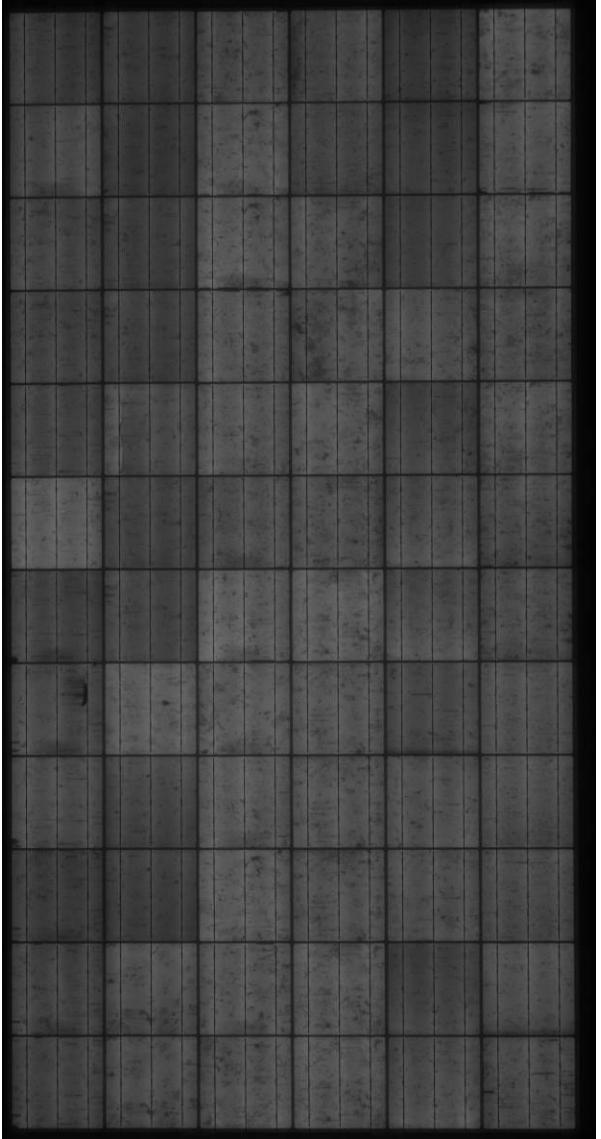
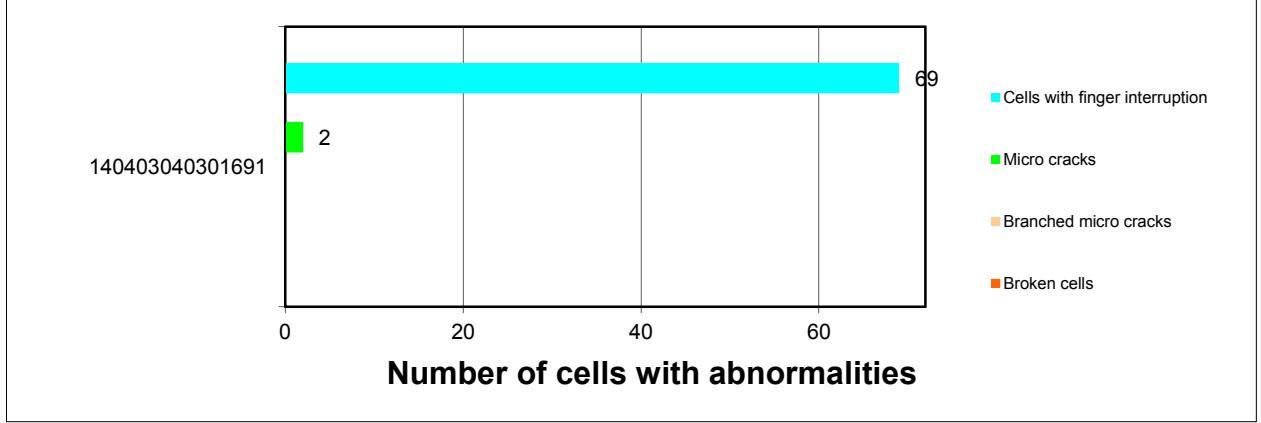
Figure 13: EL picture number: 00008849\_2016120153\_140403040301691\_RX.jpg.

The comparison of the EL pictures has shown no change regarding micro cracks or broken cells of the test specimen. No mechanical impact of the GEVA-bot on the modules could be recognized over the whole cleaning period of 400 cycles.

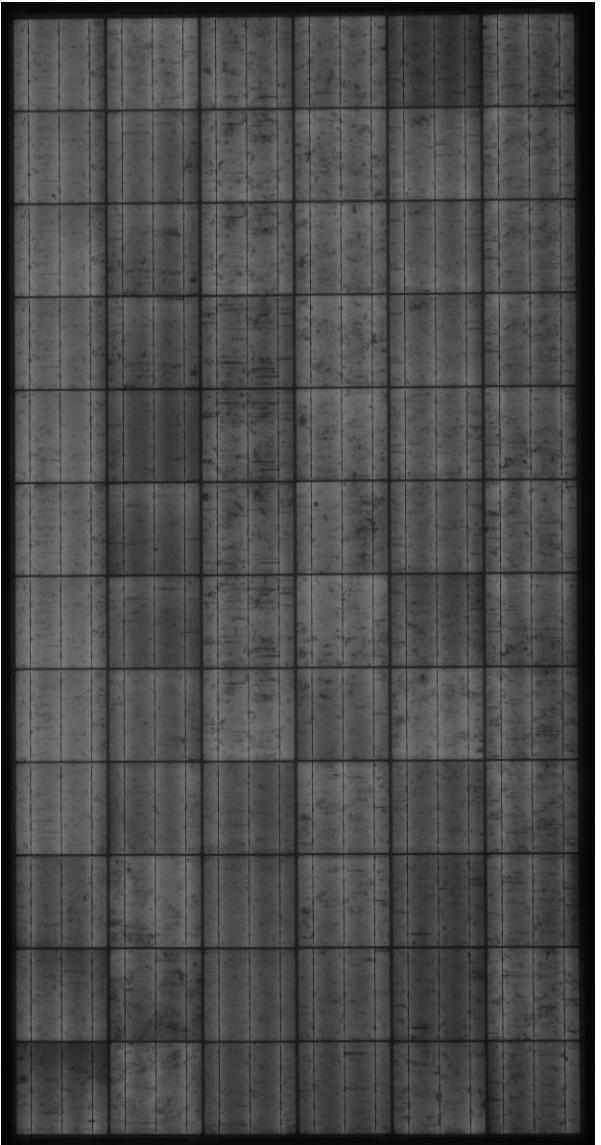
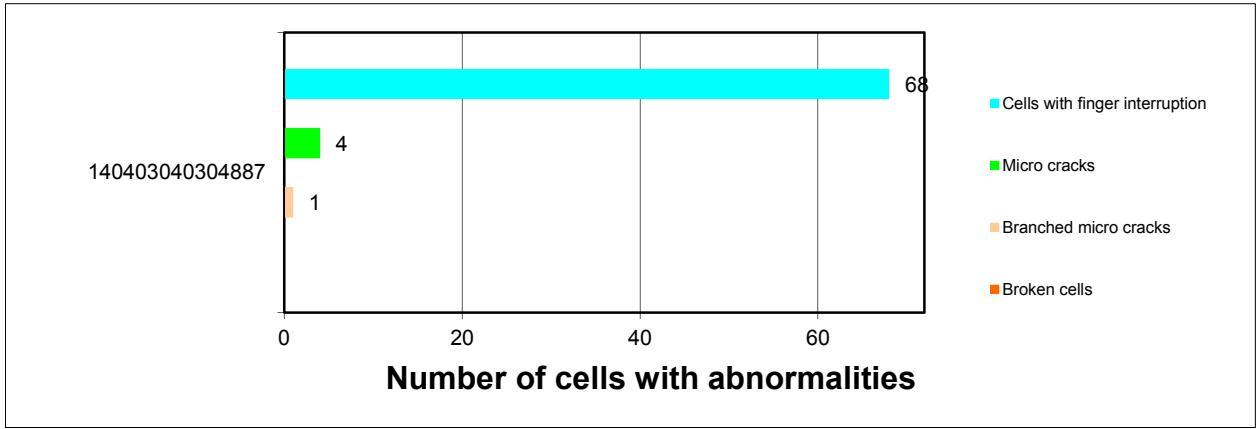
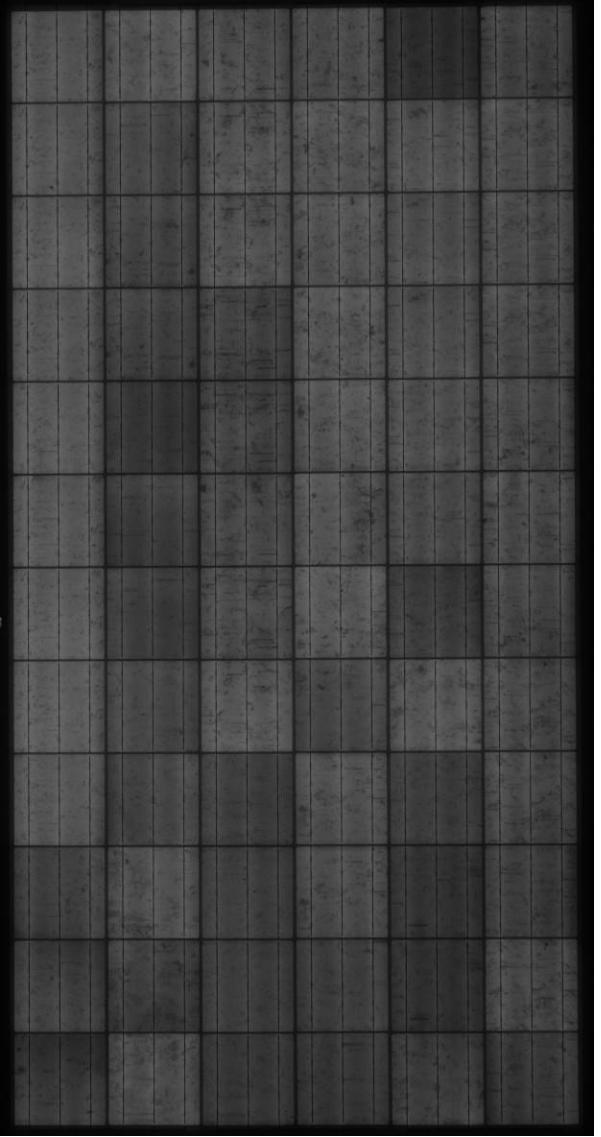
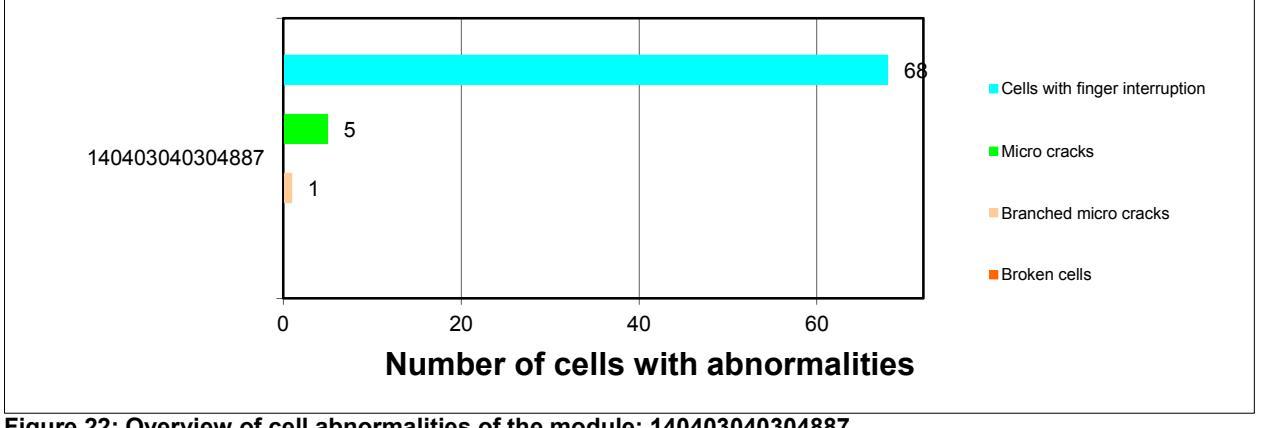
The results have shown an occurence of one micro crack. Due to the fact that this module was used as the reference and not involved in the cleaning process, the micro crack can be attributed to the module handling (201602410La\_V1\_Yingli\_Solar section 3.5.3).
